Uni-Blinds®

UNI-BLINDS® INTEGRAL BLINDS TROUBLESHOOTING GUIDE

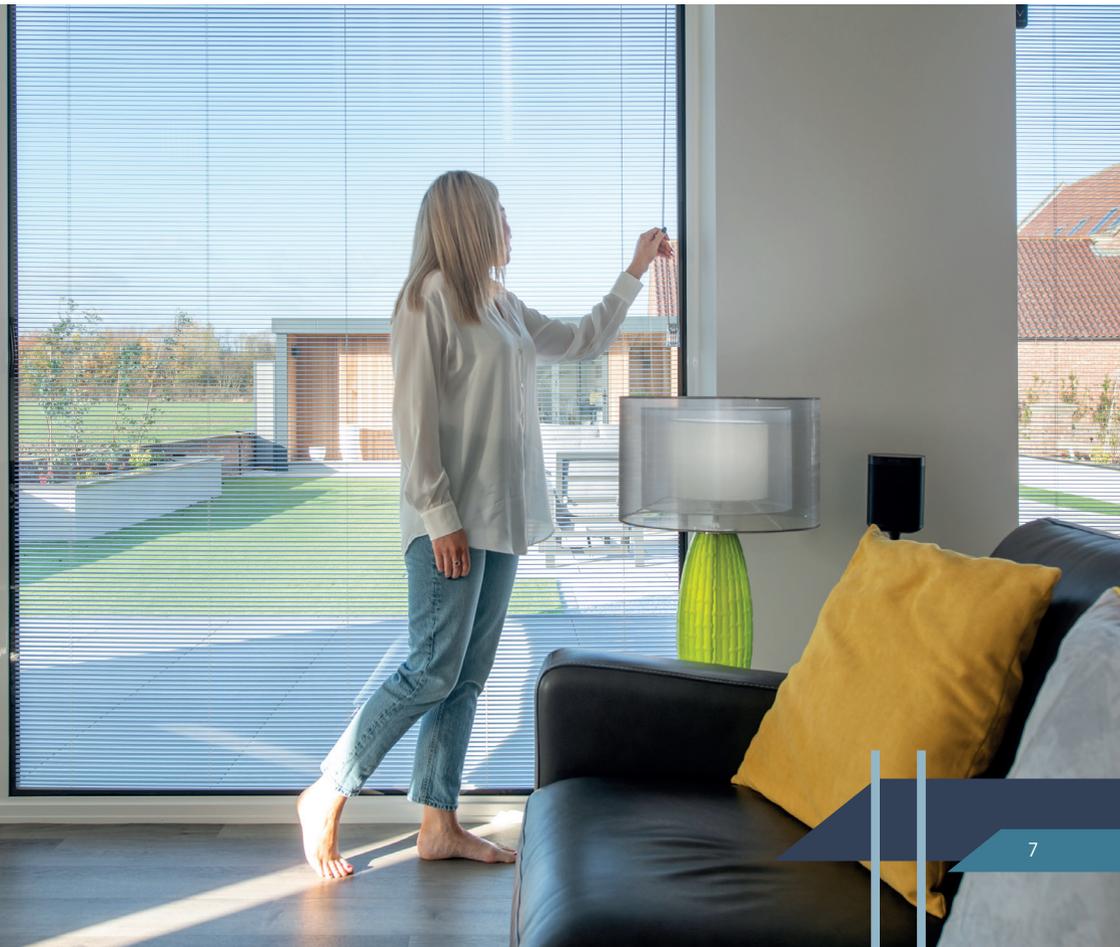
C System

The most common issue reported with the C System is 'clunky operation', which usually results from the positioning of the cord winder mechanisms on the glass.

The top mechanism contains a magnet that must align with a magnet inside the blind unit – i.e. the unit encapsulated within the sealed unit. If this is not aligned correctly, the C System cord pull will feel clunky or not work at all.

Important note: When aligning or realigning the top mechanism, use the red card template which is provided. Pop out the perforated areas and ensure the two 'ears' are pushed up into the slots at the top of the base plate.

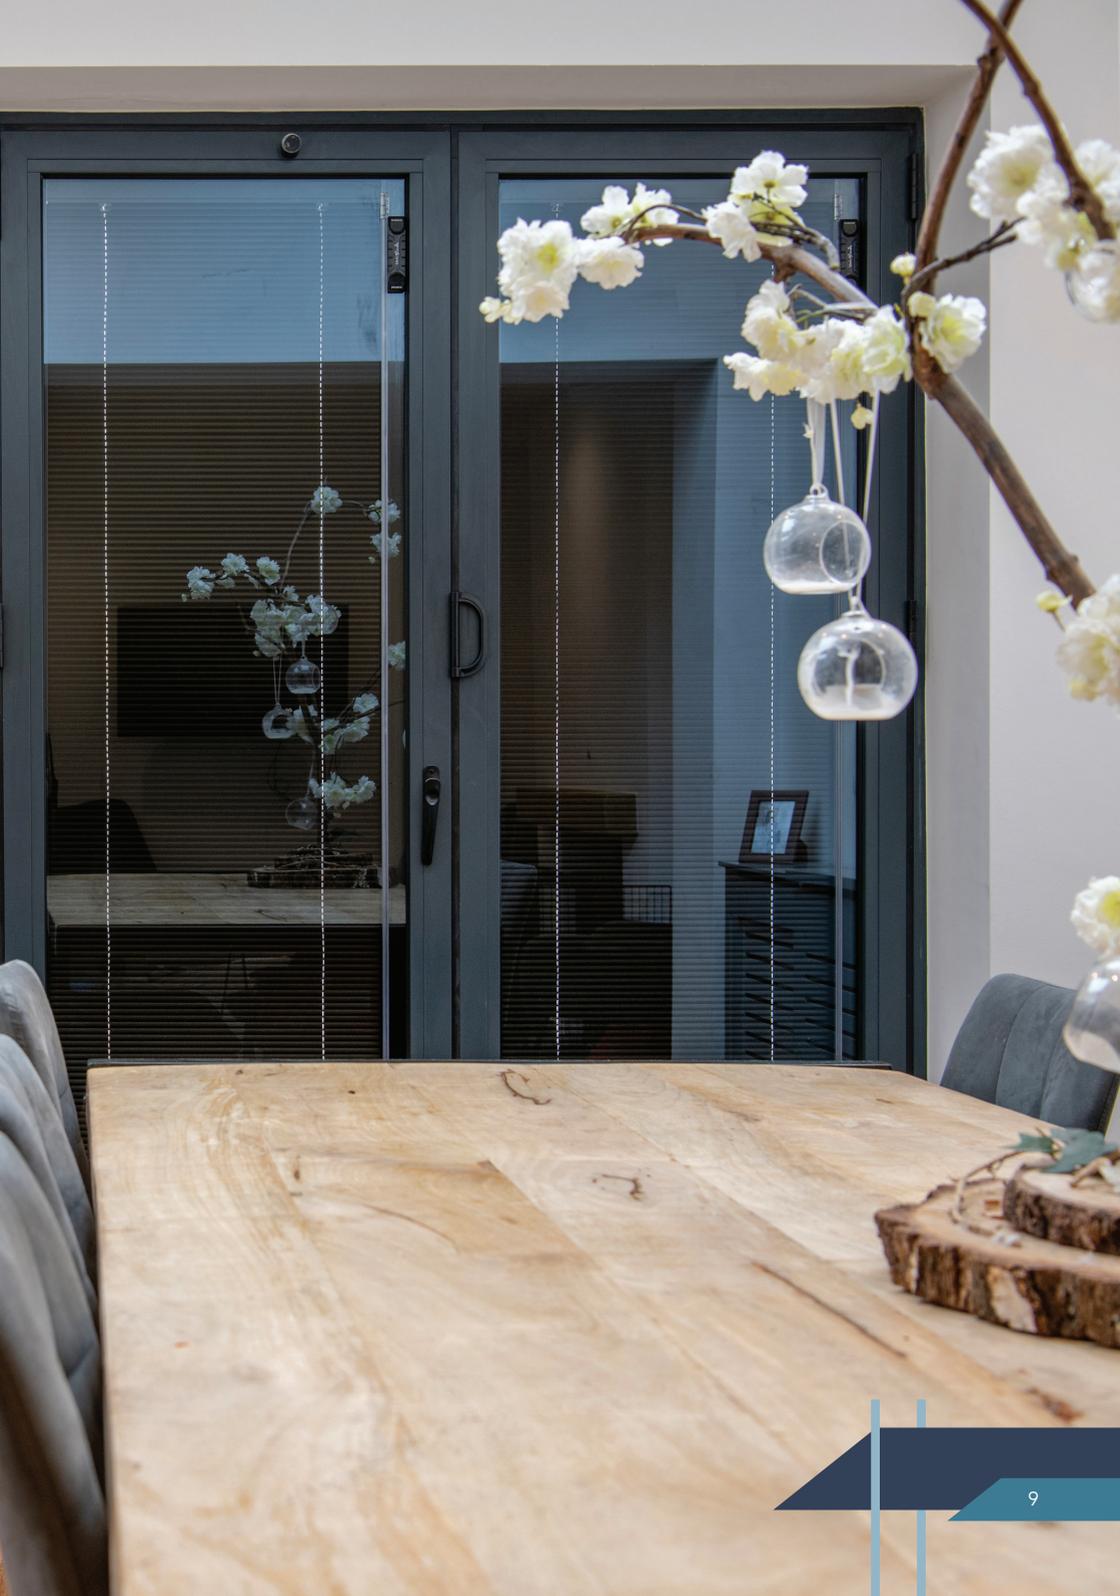
SV System and SV+ System

This is caused by the incorrect alignment of the three magnets. There are magnets inside the slider and the blind unit within the sealed unit which must line up correctly for the SV and SV+ Systems to operate correctly. The slider will only become detached when sliding it down the blind if the magnetic zone end point is reached, which is particularly noticeable on taller glass units.

3. When the slider feels like it is moving around too much, this is likely to be a result of the slider not being fitted on the track correctly. The sliders are handed and must be fitted with the small square cut outs on the underside of the slider to the track side.

Solution: Make sure the external magnetic device is aligned with the internal magnetic device, and that the horizontal groove on the external magnetic device is running along the groove of the external side track.

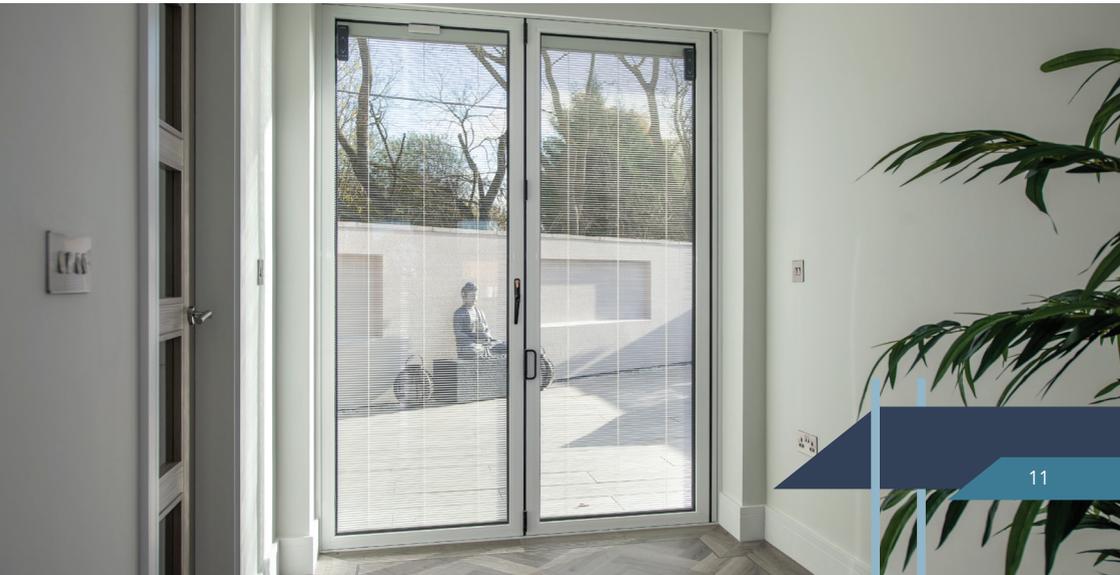
W Smart System

Solution: Switch the power off and a yellow up arrow will come up. Wait while it goes off, then switch the power back on. The green arrows will then come on and start to pulse bright green to nothing – this shows that the batteries are charging, and when they are solid green the batteries are fully charged.

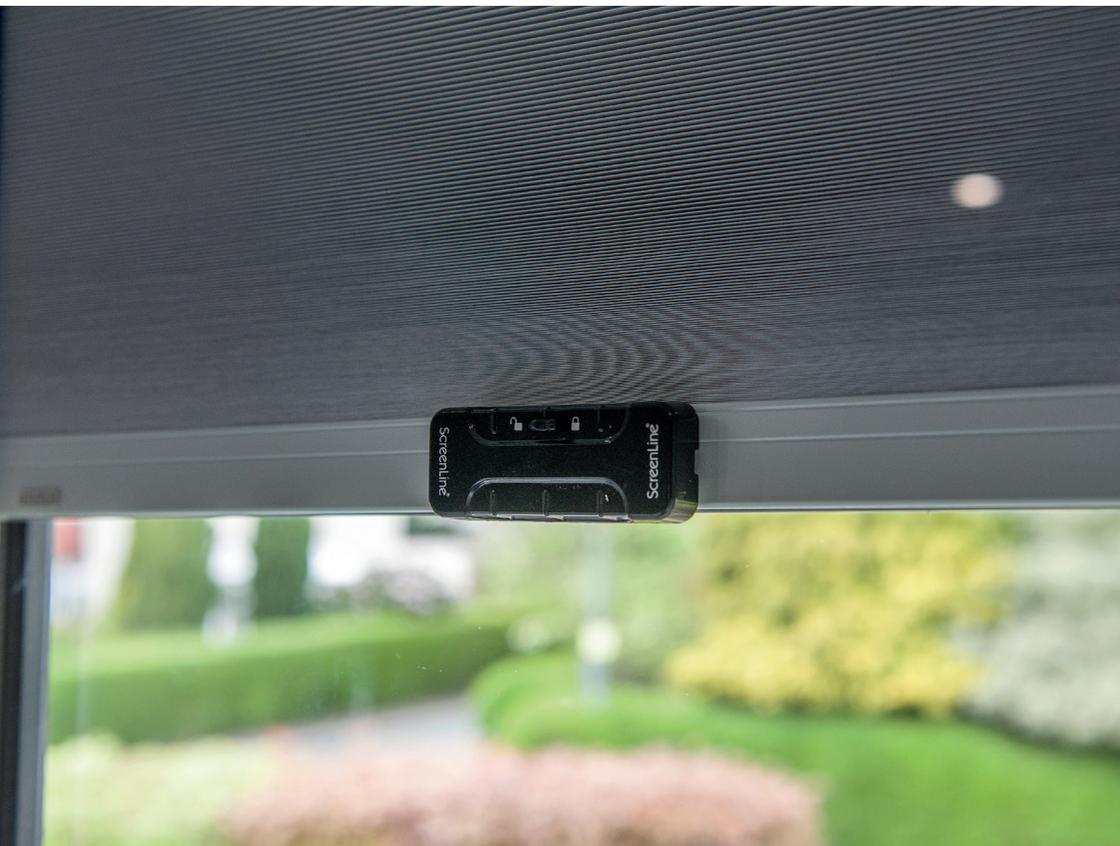
MB System

The control box must not be concealed in a location that cannot be easily accessed. This is because the control box may need to be repaired or replaced during the lifespan of the blind system, such as to rectify a specific fault. Always position in a space such as an accessible void or adjacent cupboard.

If the magnet becomes detached frequently during normal operation, this is usually because the sealed unit needs to be re-gassed.
